Shore parallel pile row breakwaters, an example of an effective coastal protection scheme

Ir. J.S. REEDIJK, Delta Marine Consultants bv, Gouda, The Netherlands

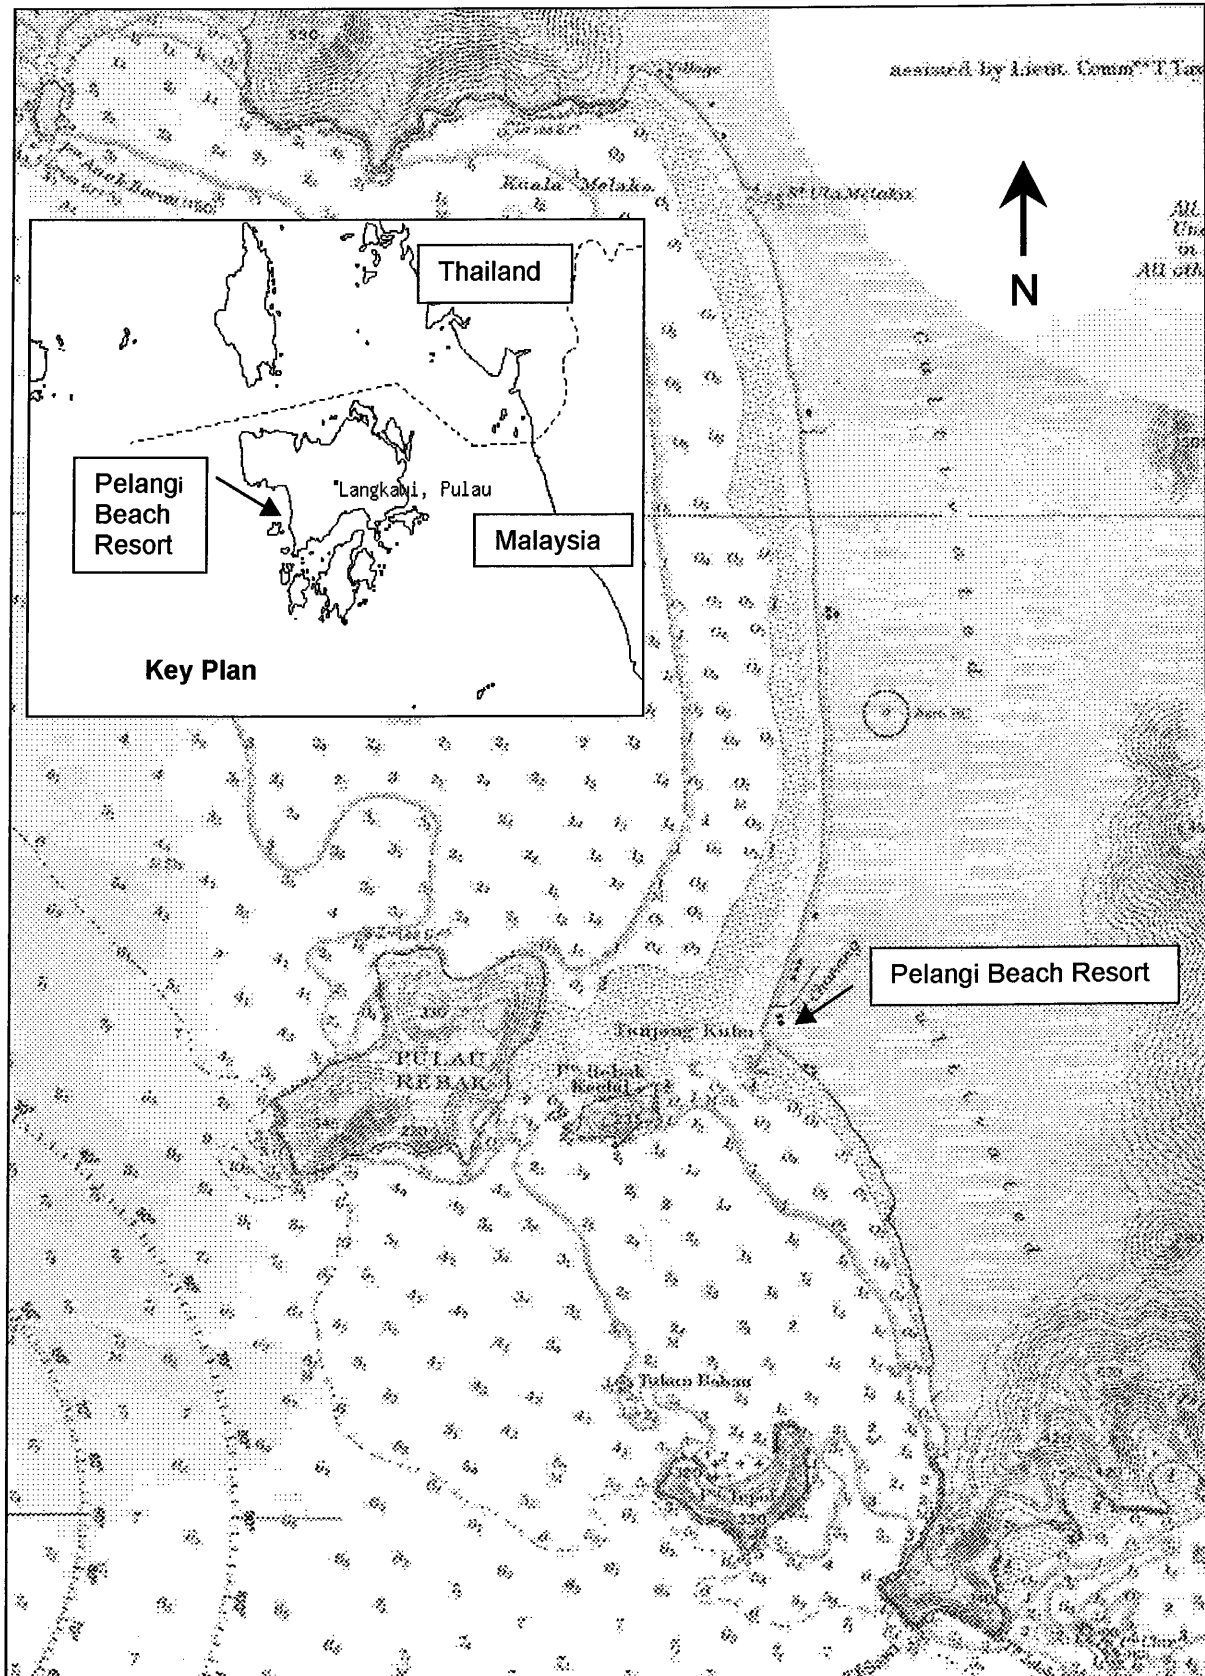
Figure 1 Bathymetry near the site

Langkawi is an island on the West Coast of Malaysia. The Pelangi Beach resort on this island was constructed on an existing spit in the lee of two small islands. Waves diffract around the two offshore islands, creating a natural cusped spit. A section of Admiralty Chart 834 is given in Figure 1 together with a key plan. Note that the depths are given in Fathoms.
