Rehabilitation of the old Cube Breakwater of Port of Poti – Georgia with Xbloc® Armour Units

Pieter Bakker, Delta Marine Consultants, Gouda, the Netherlands

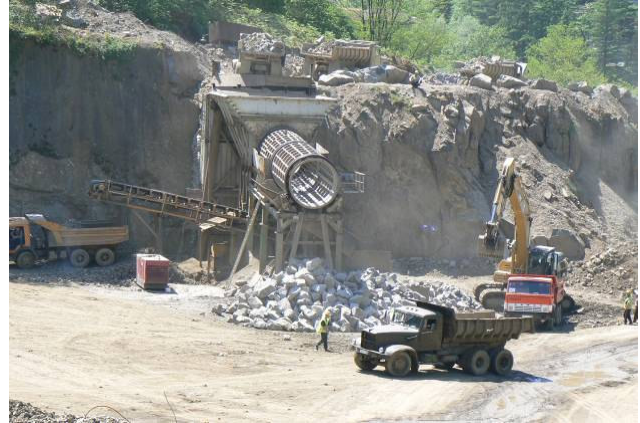
Figure 8: Drum Screen

When the big stones had been taken out, the remaining stones were loaded into dump trucks which hauled the stones to the selection plants. A drum screen was used for the major quantity of the rock selection i.e. producing 0-1 kg, 1-60 kg, 60-300 kg and 300-1,000 kg. The separated material falls down into separated sections where a wheel loader took the materials and loaded it onto the road trucks travelling to the various graded stockpiles on the stockpile area.

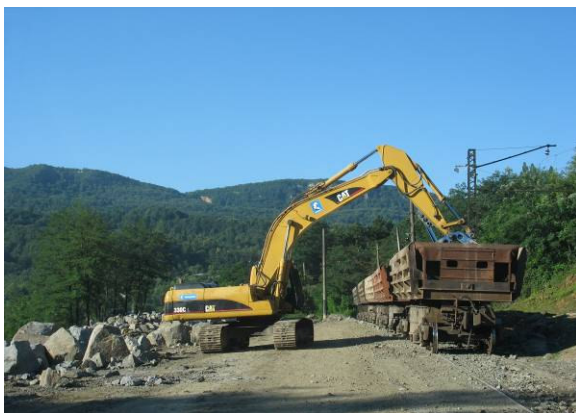
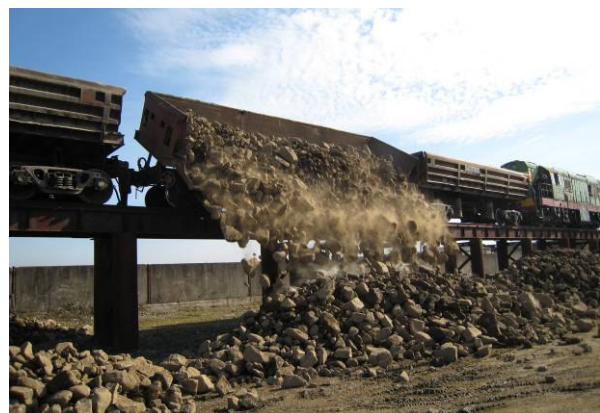
Figure 10: Loading and unloading of rock transport wagons

The railway had a small siding into Kursabi, suitable for about 4 wagons. At Kutaisi the wagons were assembled till about 20 wagons for the daily transport to Poti. At the Poti siding

the wagons were split in two for the last part towards the offloading area. Once the rock material had arrived in the city of Poti it was unloaded by means of tipping the so called duncan wagons. Once dumped, the rock would be loaded onto 6 to 10 m³ trucks which hauled the rock over a purpose built construction road towards the stock pile area close to the port.

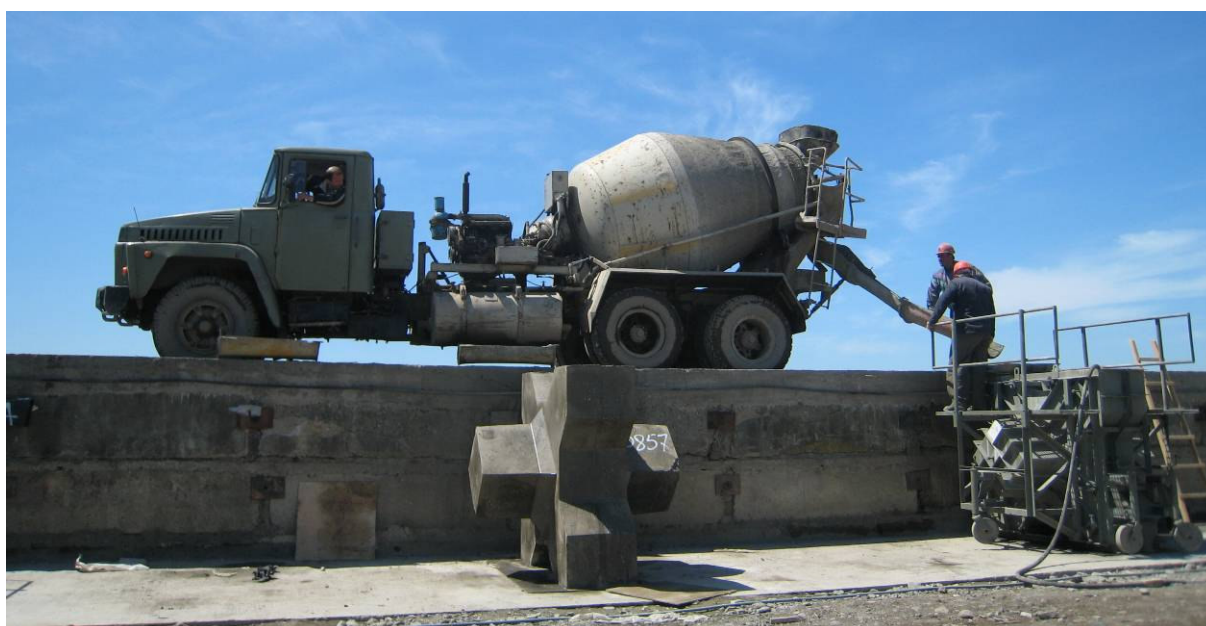
Figure 11: Pouring Xbloc from concrete mixing truck

The Xblocs were cast on site using 30 steel Xbloc moulds that were produced in the Netherlands and transported to Georgia by road. The moulds were filled directly from concrete mixing trucks which reached the moulds by means of an elevated road way. The trucks were filled under a batching plant at close distance from the production site. The moulds consist of two identical mould halves, i.e. each mould half could be connected to each other mould half. This was done to optimize the production cycle by enabling two adjacent mould halves to be turned around, connected and filled again immediately after striking the mould from a completed block. With this casting method a production speed of one Xbloc per mould per day was achieved whereas the units were left in place 2 days before transporting them to the storage area.

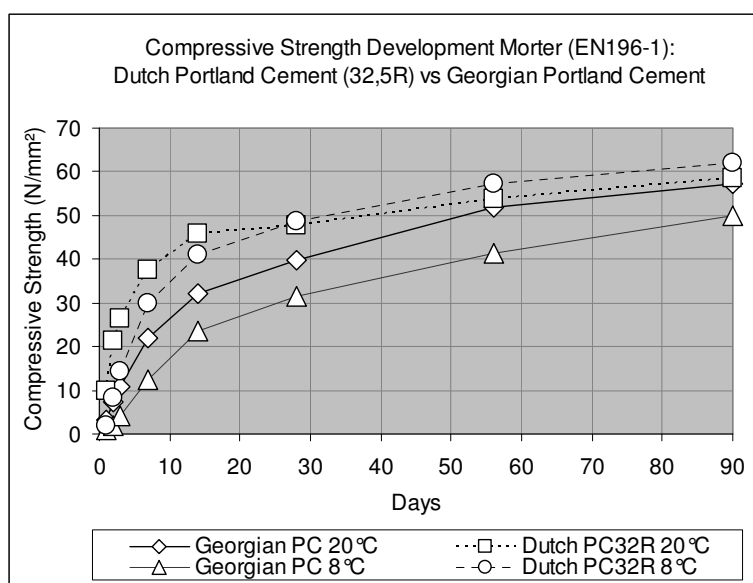
FIGURE 12: Compressive Strength at 8°C and 20°C

Furthermore the compressive strength development of the cement was tested over a duration of 90 days at a temperature of 20°C and 8°C. These results were compared to the strength development of a more standard type Dutch cement at these same temperatures. The results of these tests indicated that the strength development of the Georgian cement was indeed slow, especially at low temperatures, but that the strength increased significantly between 28 days and 90 days.

For the production of the Xblocs the concrete mix was based on locally available sulphate resistant Portland cement. On paper this mix design was suitable to obtain the concrete grade that was required for the production of Xblocs (C25/30). However from cube and cylinder compression tests it was concluded that the concrete strength development was very slow and that the strengths after 28 days were lower than expected. For this reason the cement was investigated in more detail in a specialised laboratory in The Netherlands. From this analyses it was concluded that the cement contained a relatively low quantity of Alite (C3S; responsible for early concrete strength development) and a high quantity of Belite (C2S; generating concrete strength later in the hardening process). Whereas common Dutch cement contains around 60% Alite and 10% Belite, the cement used in Poti contains 40% Alite and 30% Belite.

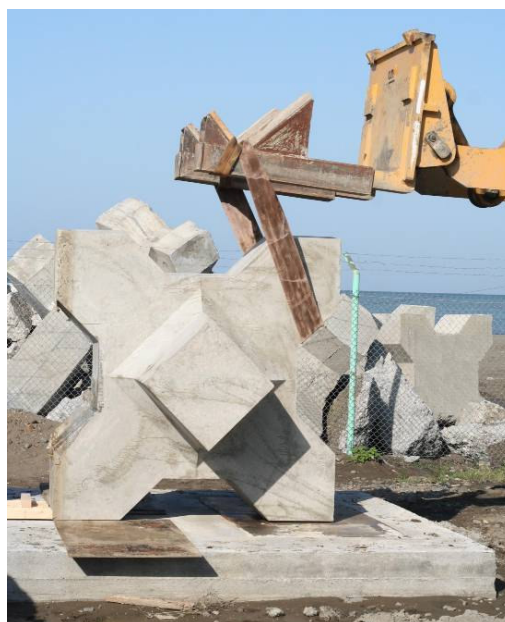
Figure 13: Test Setup Drop Tests

Due to the slow concrete strength development some units were observed with settlement and shrinkage cracks (slow strength development leads to a longer plastic period and hence to more time for cracks to develop). These cracks were encountered either in the top surfaces of the units (shrinkage cracks) or in the “arm pits” and “thighs” of the units (settlement cracks). In order to test the robustness of these units, a number of units were subjected to drop tests on a solid concrete floor covered by a steel plate. The objective of these drop tests was to simulate as good as possible the loads an armour unit could undergo if wave loads would cause it to rock against neighbouring units. Although the drop tests were done with units that were considered to be the more severe units, no damage was caused by the tests during which units were dropped on a leg with fall heights increasing in steps of 5cm up to a fall height of 50cm and other units were rolled over 25 times.

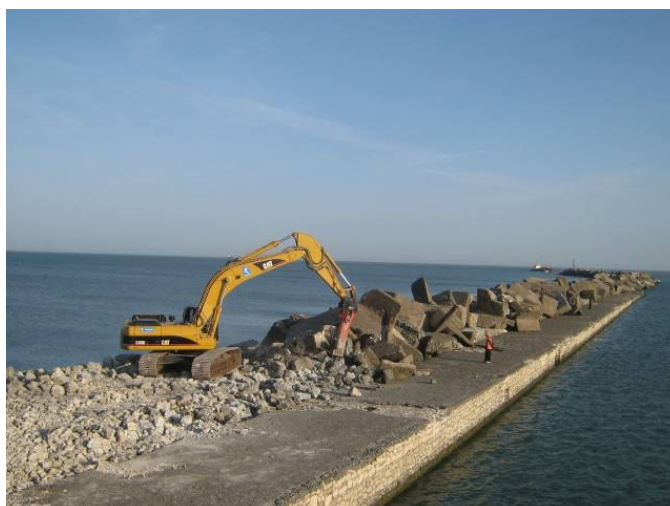
Figure 14: Impression of Rock Hammering

In order to create a platform for the new construction some 8.200 cubic meters of existing concrete cubes had to be removed. The cubes had an average weight of approximately 60 ton per piece and were of varying quality. Lifting these cubes was considered a potential unsafe operation and a safer solution was found in destroying the blocks in a controlled manner by use of hydraulic hammers. The hammers used were “Rammer 100’s” mounted on a CAT330 and a CAT375 long reach excavator. The hammers with a working weight of 4 ton were equipped with pointed chisels of 10 centimetre diameter.

The first job that had to be done when the first machinery entered the breakwater was to create a working space by hammering a way through the cubes. The excavators aimed their hammers perpendicular to the cubes surfaces to constantly break the cubes into smaller pieces. The concrete was broken into fragments of approximately half a meter. Because the excavators moved over the hammered material it broke into smaller pieces. The obtained material was not removed but simply fell into the voids between the remaining cubes. The cubes above a level of 1 meter CD were removed in this way at an average rate of 400 m³ per 24 hours.

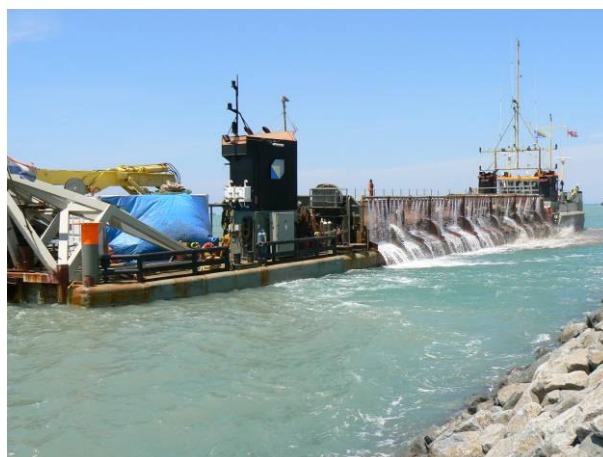
Figure 15: Rock dumping with Arca

The placement of the different gradations of rock can be subdivided into two construction methods namely 1) with land based machinery; and 2) with the Side Stone Dump Vessel ARCA (Figure 15). Due to the ability of this vessel to operate in shallow water (2,6 m) and due to the long reach capability of the excavator (21 m) the two types of equipment were able to cover each others working area. The ARCA works with a multi conveyor-belt dumping system. The loading deck consists of six pairs of conveyor-belts which are separated by five coamings. The working direction of the conveyors are perpendicular to the vessels hull. Upon arrival on the dumping site the conveyor belts are started and the loaded material will be moved from the deck into the water. A DGPS system insures its correct position for dumping and sailing speed while dumping. The vessel carries 550 ton of rock and did a maximum of four trips in a twelve hour working day.

The first two rock layers have been applied on the sea bed with the ARCA. These filter layers (2-50 mm and 1-60 kg) were placed against the existing breakwater. From the breakwater the long reach excavator applied the next layer (60-300kg) on top of the filter layer against the breakwater slope. Once this layer was fully applied the next layers (1-300kg and 300-1000kg) were placed by the excavator. The 300-1000 kg layer was applied on top of the filter layers in the berm and against the slope, creating an under layer for the Xblocs. Finally the 60-300kg layer in the breakwater toe was placed by the ARCA.

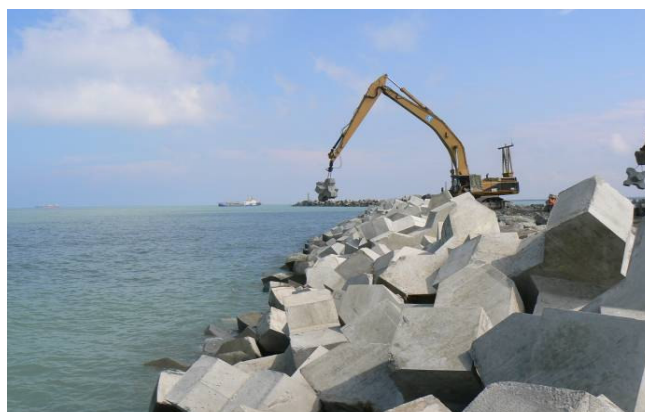
Figure 16: Xbloc placement

The Xblocs were transported by barge from the storage area to the breakwater where they were unloaded by excavator and placed with the CAT375 long boom excavator equipped with the Boskalis Crane Monitoring System. This system enables the crane operator to know the position of the boom and accurately release the units at their predefined location.

Prior to the placement a computer model was prepared to determine the locations of all the units to be placed. The units in the lowest row were placed on three points. The other blocks were placed with one leg pointing downwards so that the blocks easily find their position in between the units of the previous row.

As the placement accuracy of the first two rows affects the ease of placement of the remaining rows, diver inspections were carried out after the first and second row. Due to the availability of the crane monitoring system, the effective quick release hook and the simplicity of the Xbloc placement procedure, high placement rates were obtained of approximately 20 units per hour below the water line and up to 40 units per hour above the water line.

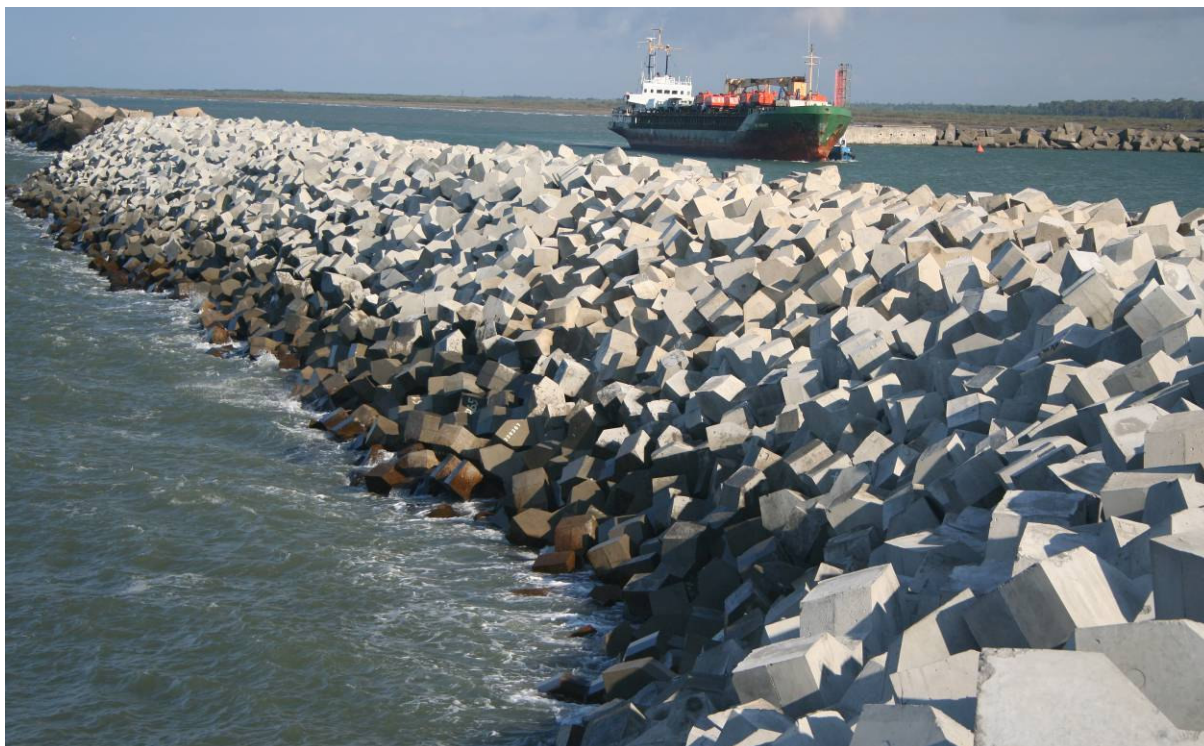
Figure 17: Impression of completed rehabilitation works

After a short interruption of the construction during the Russian-Georgian conflict in August 2008 when the contractor temporarily abandoned the site, construction was re-started in September 2008. When the Xbloc placement was completed, the remaining wedges between the Xblocs, the cubes and the wall structure were filled with Xblocs. Finally the breakwater crest was covered with the Xbase units and in October 2008 the rehabilitation project was completed.
