## **Shore parallel pile row breakwaters, an example of an effective coastal protection scheme**

Ir. J.S. REEDIJK, Delta Marine Consultants bv, Gouda, The Netherlands

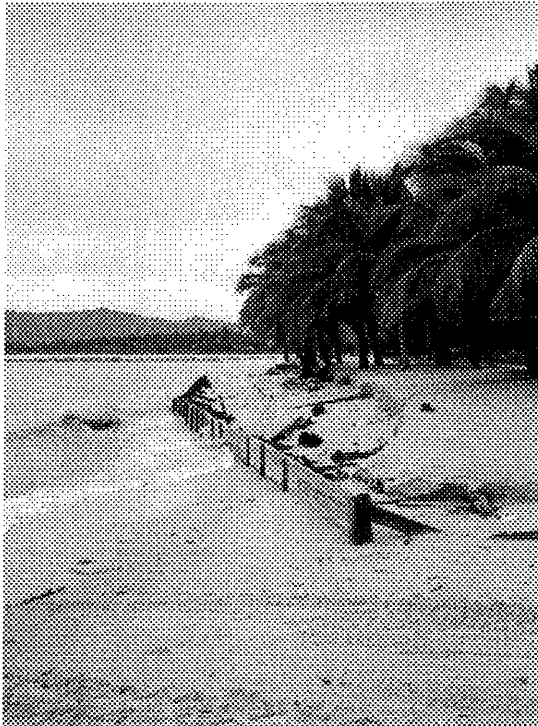
Photograph 1. Failed wooden wall

The resort owners tried several measures to stop the erosion. However, none of them were successful. First interlocking concrete blocks were put on the beach, but these disappeared below the sand after a storm. The remaining blocks are now in use as pavement for footpaths. Then small wooden walls were applied, but these were overtopped and undermined, as shown in photograph 1. Finally sandbags and rock were put on the beach, providing an unsightly view, as shown in photograph 2. After each storm new sandbags had to be placed, and the beach had to be reshaped with bulldozers.

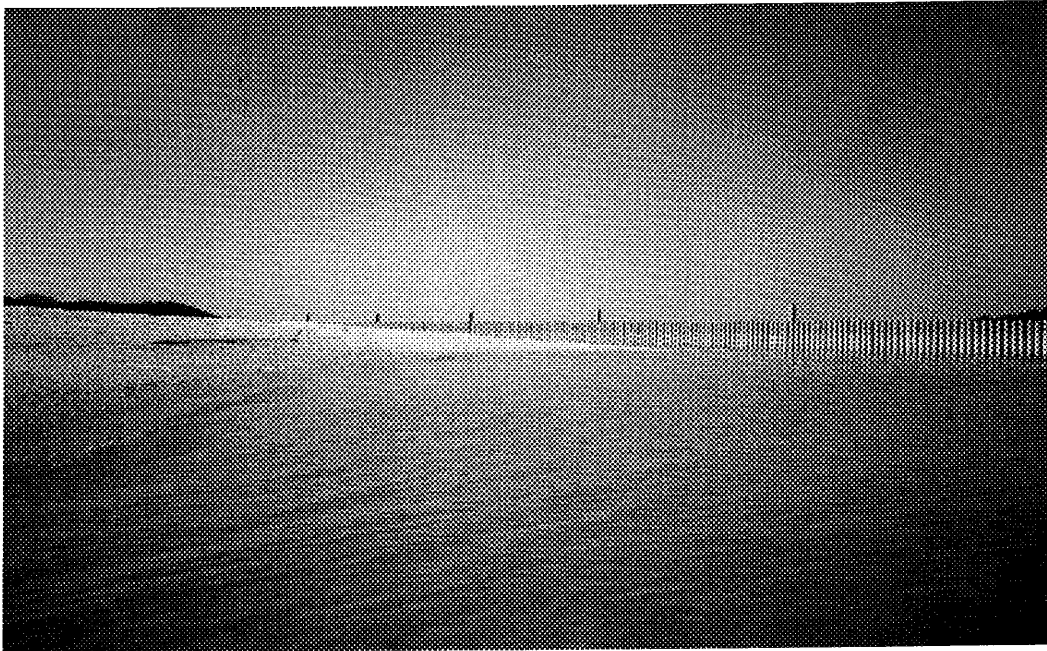
Photograph 3. Southern pile row at low water level

In February 1998, two years after construction, a follow up visit was carried out. At the moment of arrival the positive effect of the pile rows was obvious: the beach has restored completely in the lee of both pile rows. Although no replenishment was carried out after construction, the coastline has developed seaward over almost the full length of the beach at the resort. The situation during this visit was fully satisfactory for the client, except for some corrosion problems of the steel pile caps [which were not immediately coated after construction].

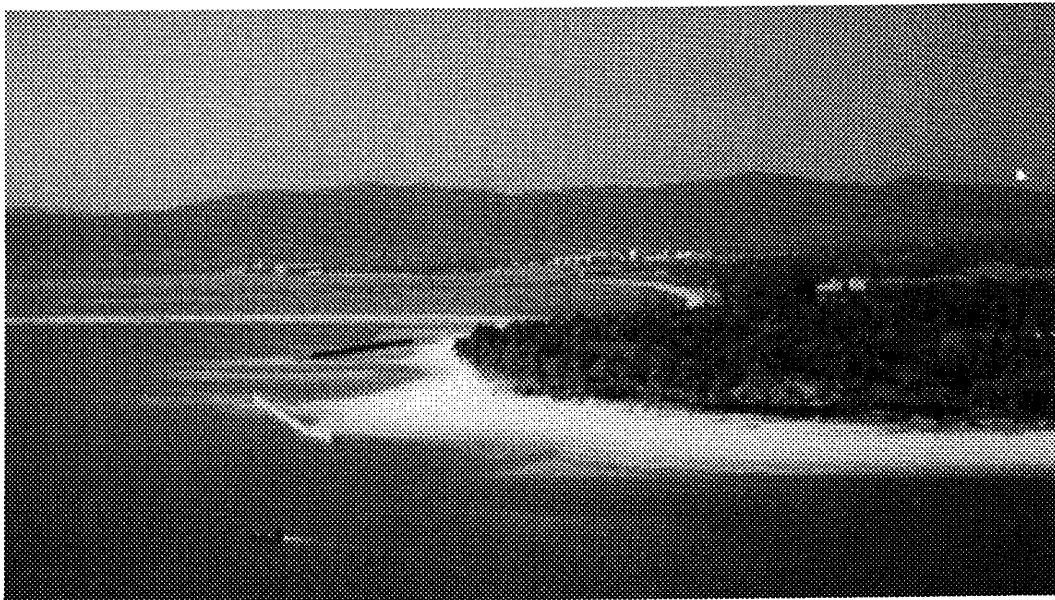
Photograph 4. Overview of the beach resort with pile rows, seen from the south

In general the pile rows performed very well. The salient sand bodies on the lee side of the pile rows almost developed into shore connecting tombolo's. The volume of sand trapped behind the pile row is more than was expected. Since the Client did not carry out the designed beach replenishment, the material trapped behind the structures was eroded from neighbouring beaches.

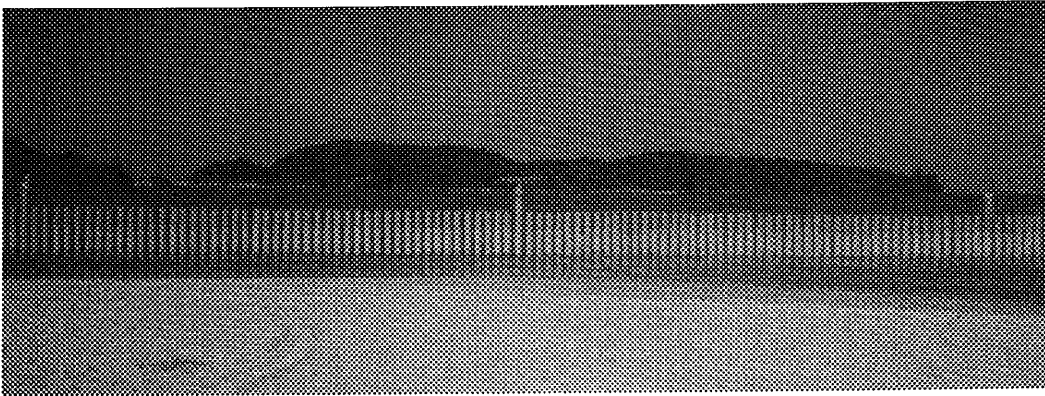
Photograph 5. Southern pile row seen from the east

Minor erosion around the piles can be observed. The scour along the pile rows is generally less than one pile diameter. The open structure also allows cross shore transport to propagate through the pile rows. This is illustrated clearly by small sand bars which develop through the pile rows, continuing on both the exposed and lee side of the piles.

For the location of the Pelangi beach resort, the pile row breakwaters are very effective in restoring the beach. The beach was restored within one year, even without the proposed replenishment. The pile rows are only of minor visual impact, and recreation is unhindered. New for this type of structure is the open nature of the breakwater. Normally shore parallel breakwaters are impermeable to sediment. The pile rows at Langkawi show that the development of the coast line can proceed without being interrupted by the breakwater. The example of the sand bar through the southern pile row shows that this actually takes place.

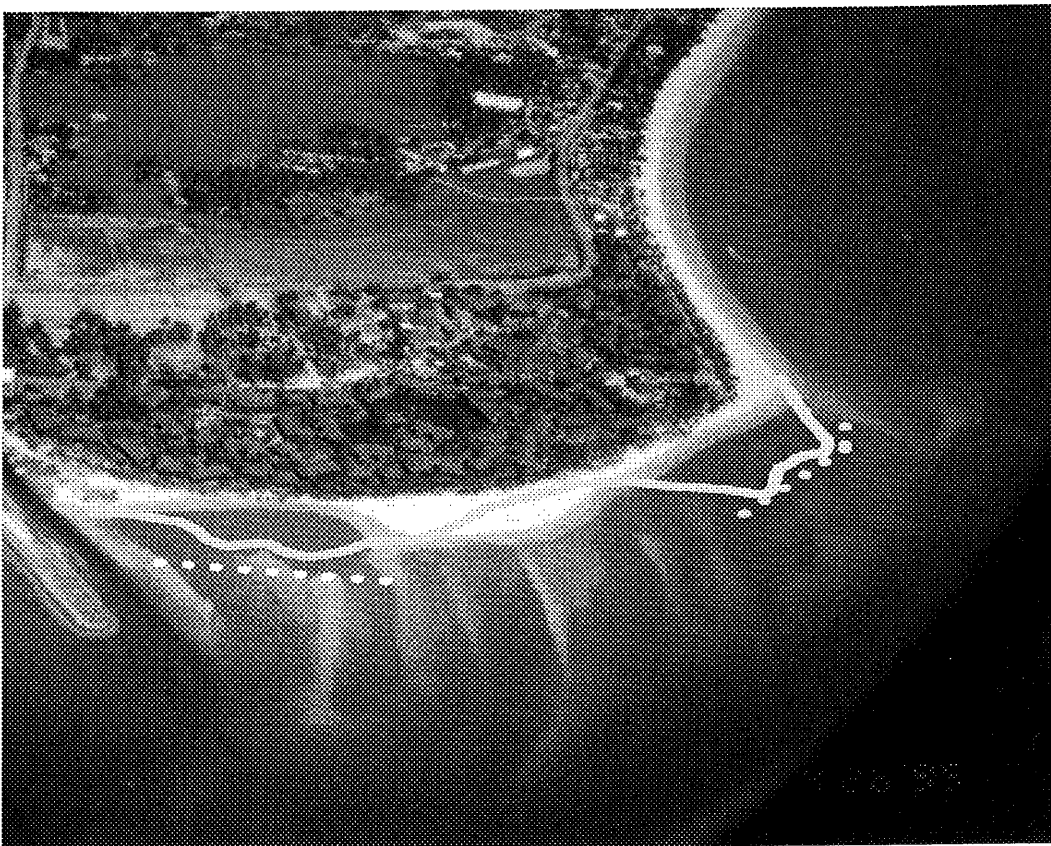
Photograph 6. Situation before and after construction of pile rows

In photograph 6 the situation is shown before the pile rows were built. The location of the pile rows and the present shape of the beach is also indicated. It clearly shows the positive effect of the pile rows on the beach. After construction of the pile rows no more maintenance of the beach has been required.
