# Revaluation of Concrete Design in Marine Engineering

J. Overbeek<sup>a,\*</sup> and A. Q. C. van der Horst<sup>b,†</sup>

<sup>a</sup>*Delta Marine Consultants bv (Singapore Branch), 6001 Beach Road, #20-03 Golden Mile Tower, Singapore 199589*

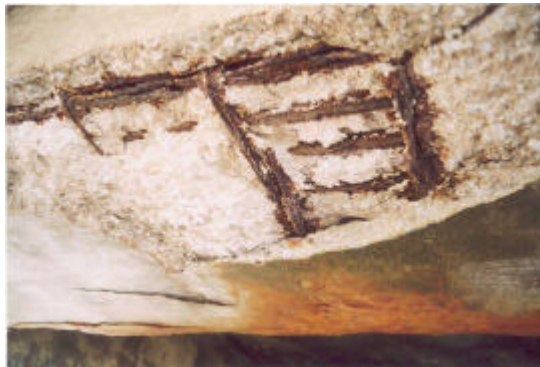
Fig. 1. Spalling at the base of a ramp over the tidal zone, the rest of the structure only shows mechanical damage.

Other areas where deterioration has been found to be more severe than on structures as a whole are those with higher occurrences of wetting and drying, particularly with seawater. These are often the undersides of structures over revetments where the slope causes increased wave run-up and/or breaking and splashing of waves leading to spray on the underside of concrete elements which is also not washed by rains. Similarly areas such as in front of mooring points can show higher incidences of delamination or spalling due to the drip of seawater from mooring lines which increases chloride levels.
